Test Intention:

In test 3486 we want to investigate the lifespan of our CFROBOT8.045 in a torsion application with $\pm 180^\circ$.

Name: Rainer Rössel Team: chainflex® Date: 15.09.2009

Series / No: CFROBOT8

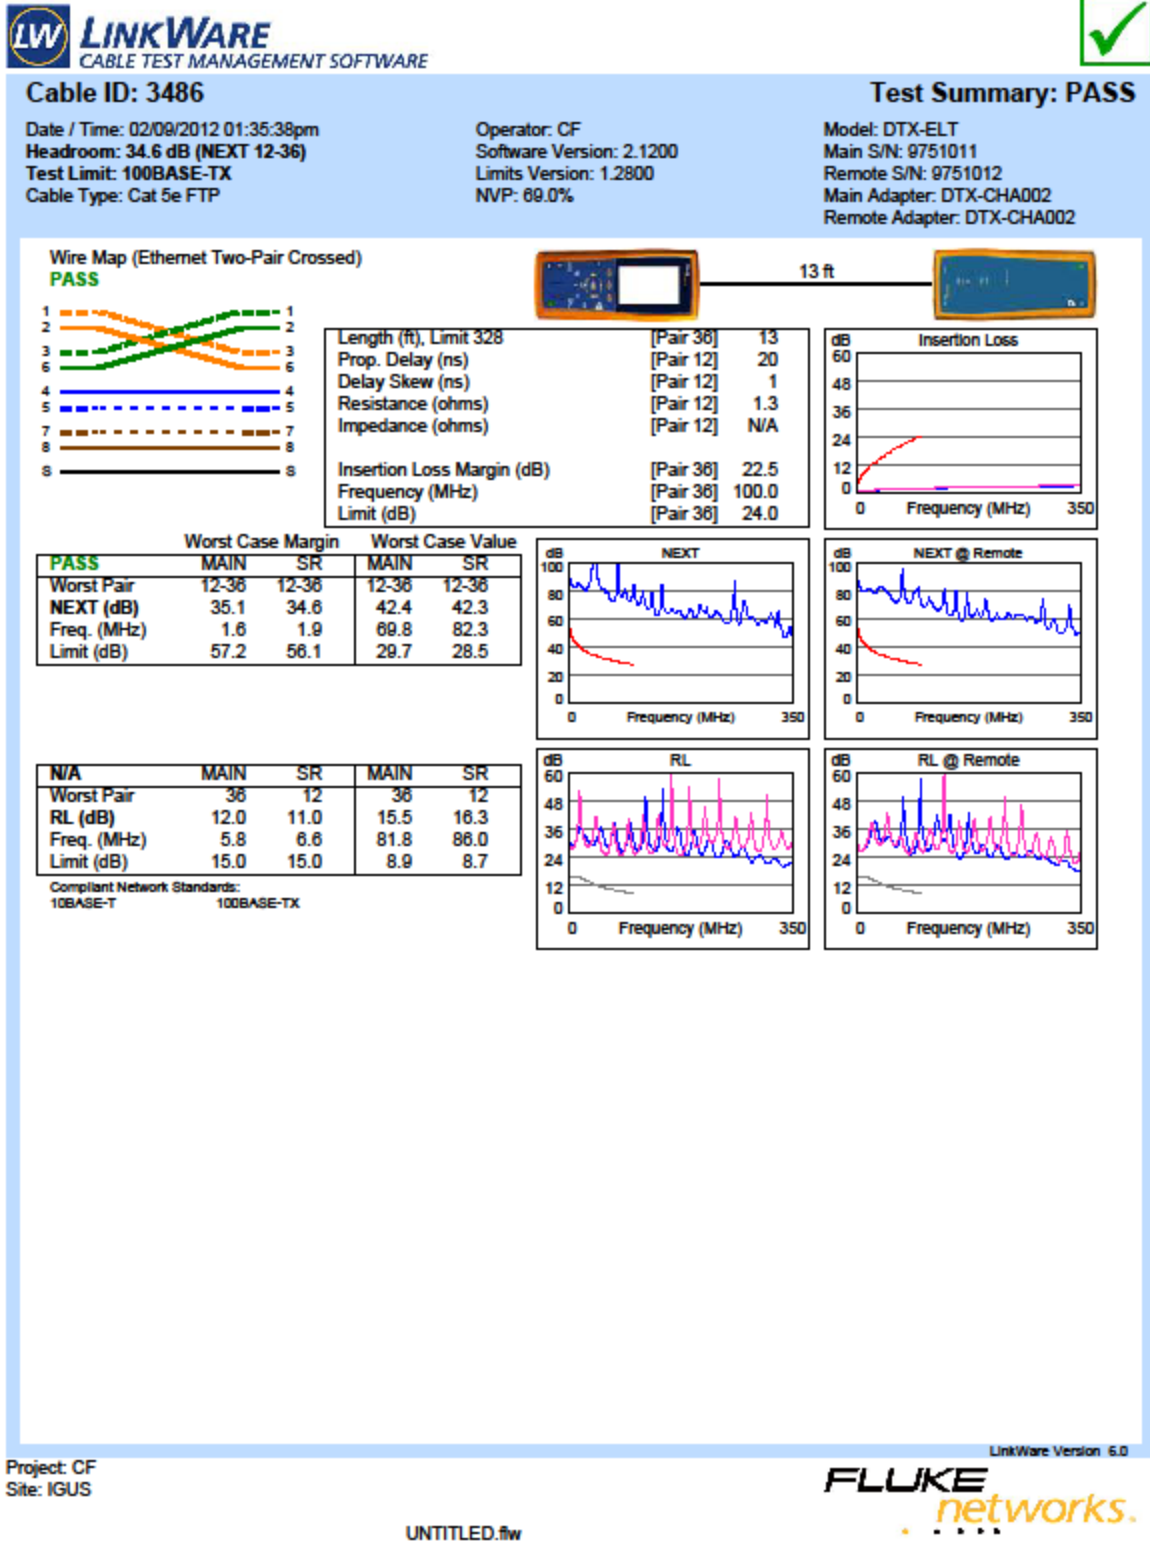
The following protocol shows the result of the Fluke measurement after 22.010.222 cycles.

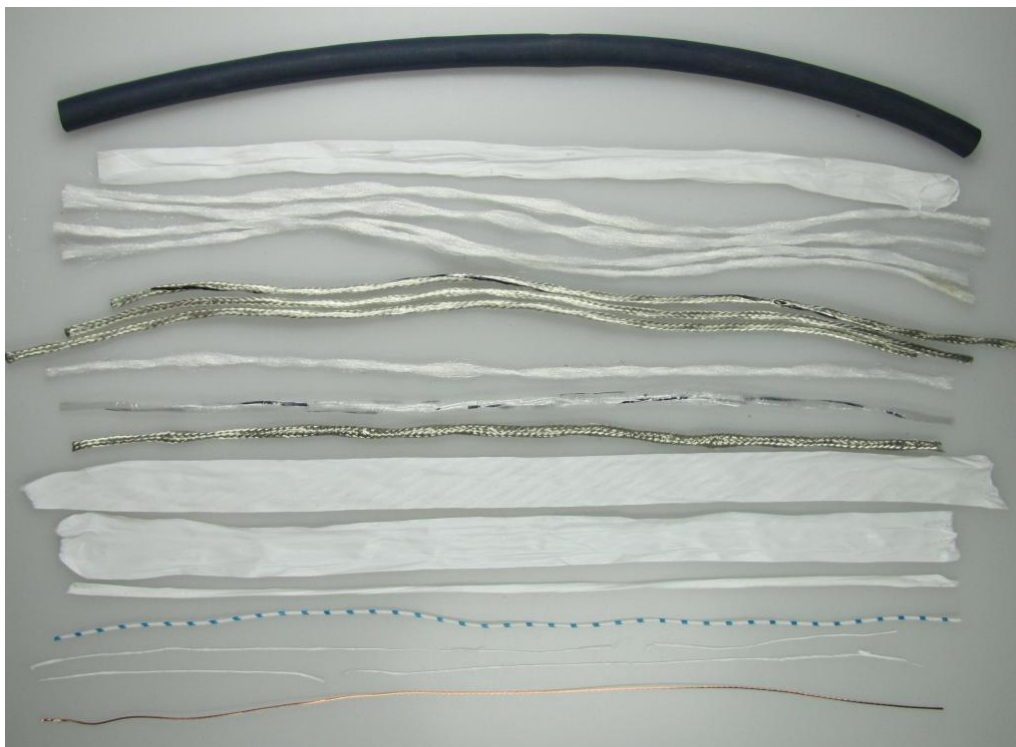
The condition of the cable no.1.1 (CFROBOT8.045) after 22.010.222 cycles

Overview of the dissected pieces of the cable no.1, CFROBOT8.045.

DS: 22.010.222	Upper fixed point	Middle of the tested cable	Lower fixed point
Outer jacket	O.K.	O.K.	O.K.
Fillers	O.K.	O.K.	O.K.
Centre element	O.K.	O.K.	O.K.
Condition shielding	Single broken wires	damaged	O.K.
PTFE tapes	O.K.	O.K.	O.K.
Condition core insulation	O.K.	O.K.	O.K.
Condition conductor	O.K.	O.K.	O.K.
